TURBIDITY MONITORING AT SELECT MDOT CONSTRUCTION SITES

STATE STUDY 225

JUNE 2012

**Prepared for:
Mississippi Department of Transportation**

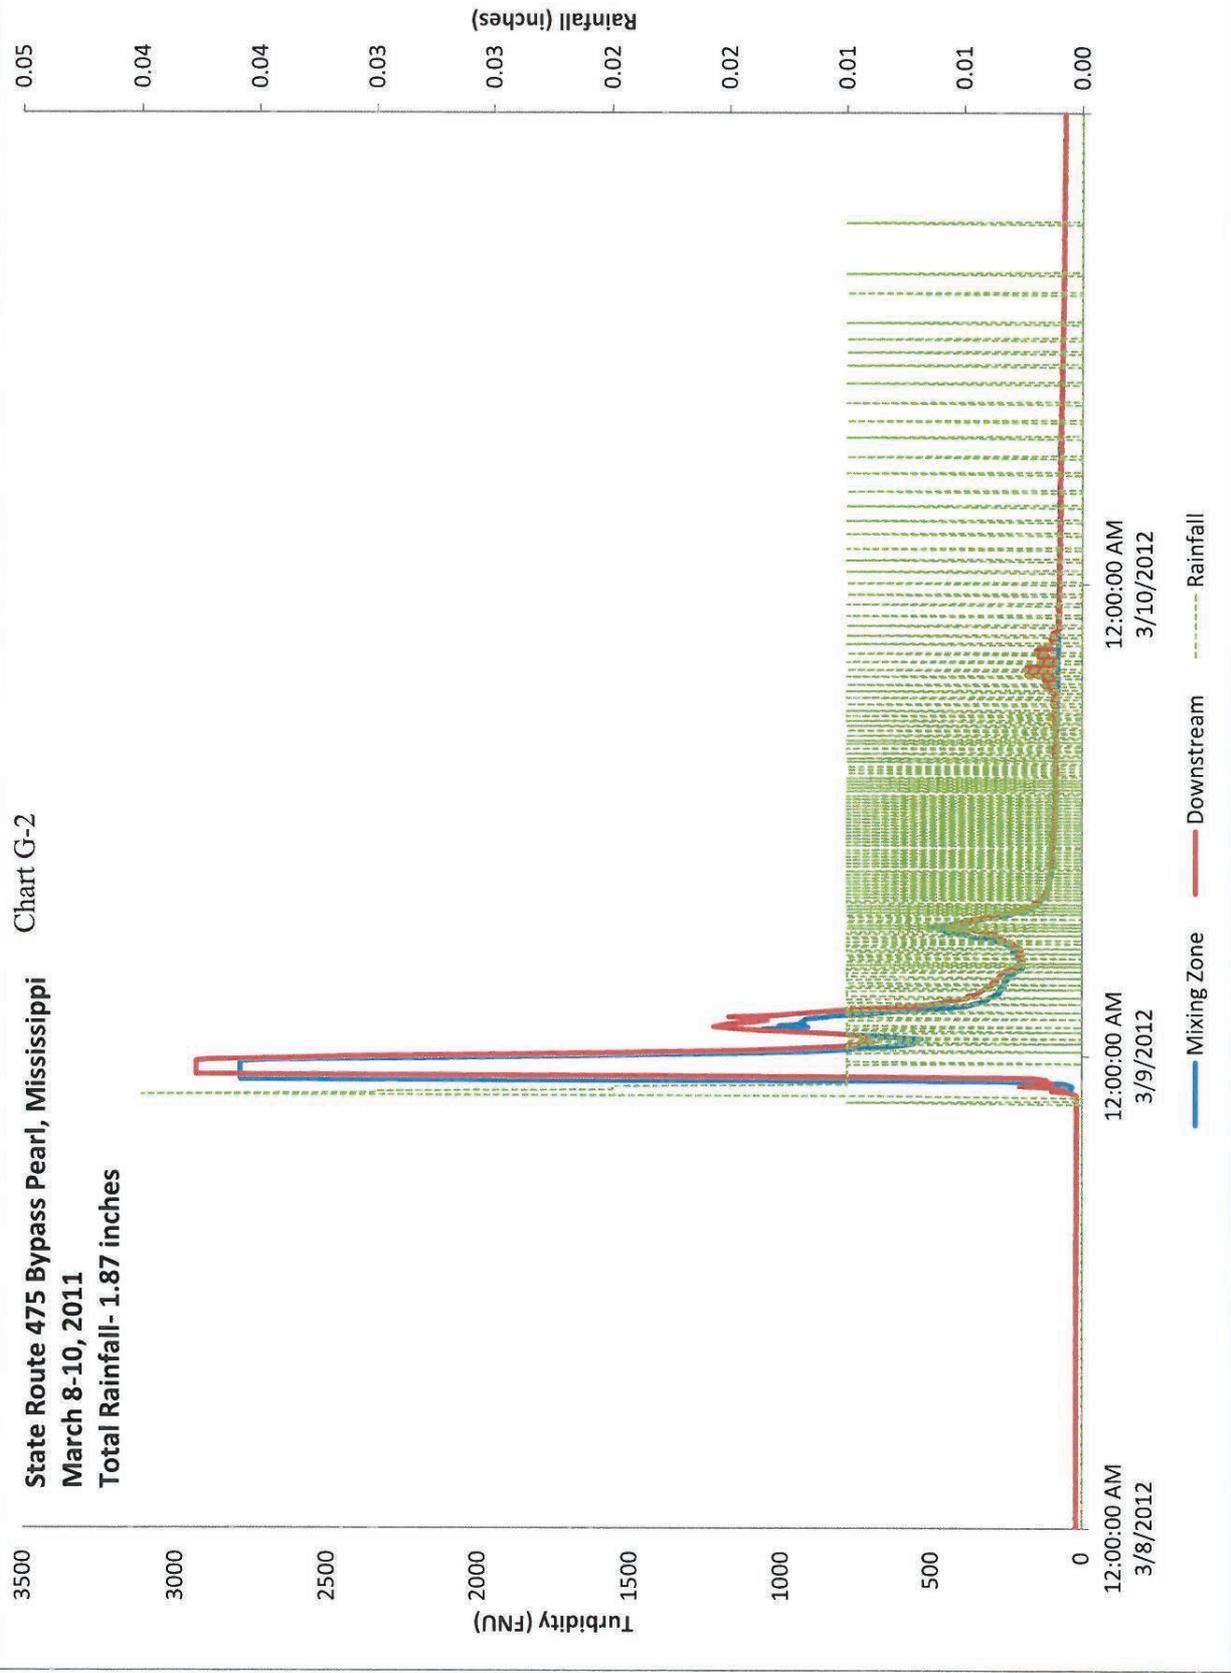
Chart G-2

State Route 475 Bypass Pearl, Mississippi

March 8-10, 2011

Total Rainfall- 1.87 inches

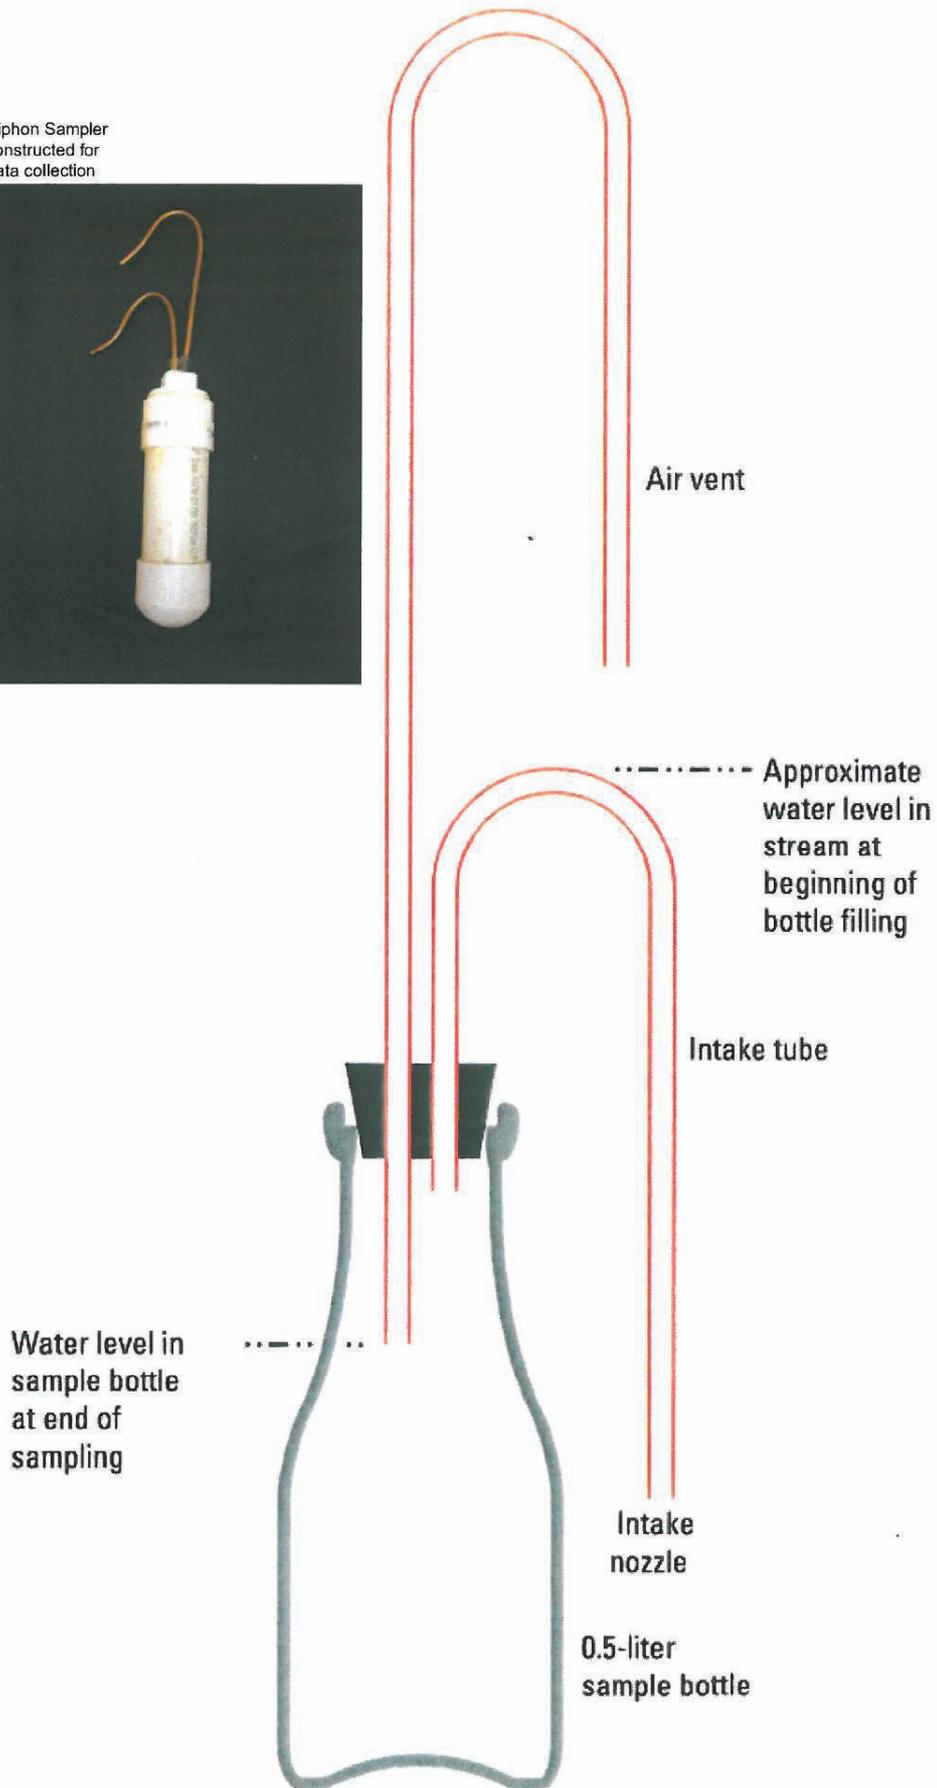
Example of Siphon Sampler Construction and Operation

Siphon Sampler constructed for data collection

Air vent

Approximate water level in stream at beginning of bottle filling

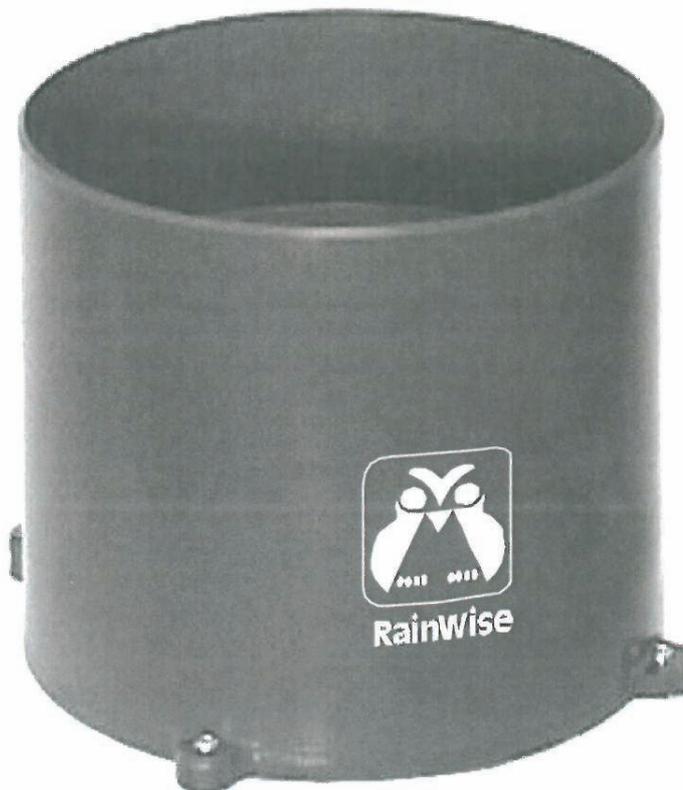
RAIN GAUGE – Polypropylene

The RainWise model RGP industrial tipping bucket rain gauge is constructed to provide accurate recording of rainfall data at a reasonable price. The 8" diameter collector meets NWS specifications for statistical accuracy.

The tipping bucket causes a reed switch to close with every increment of rainfall. This may be used in a system to determine either rainfall amount or rate. The gauge is equipped with a built-in level to aid in installation. A insect/debris screen is provided. The gauge is furnished with 50 feet of buriable cable.

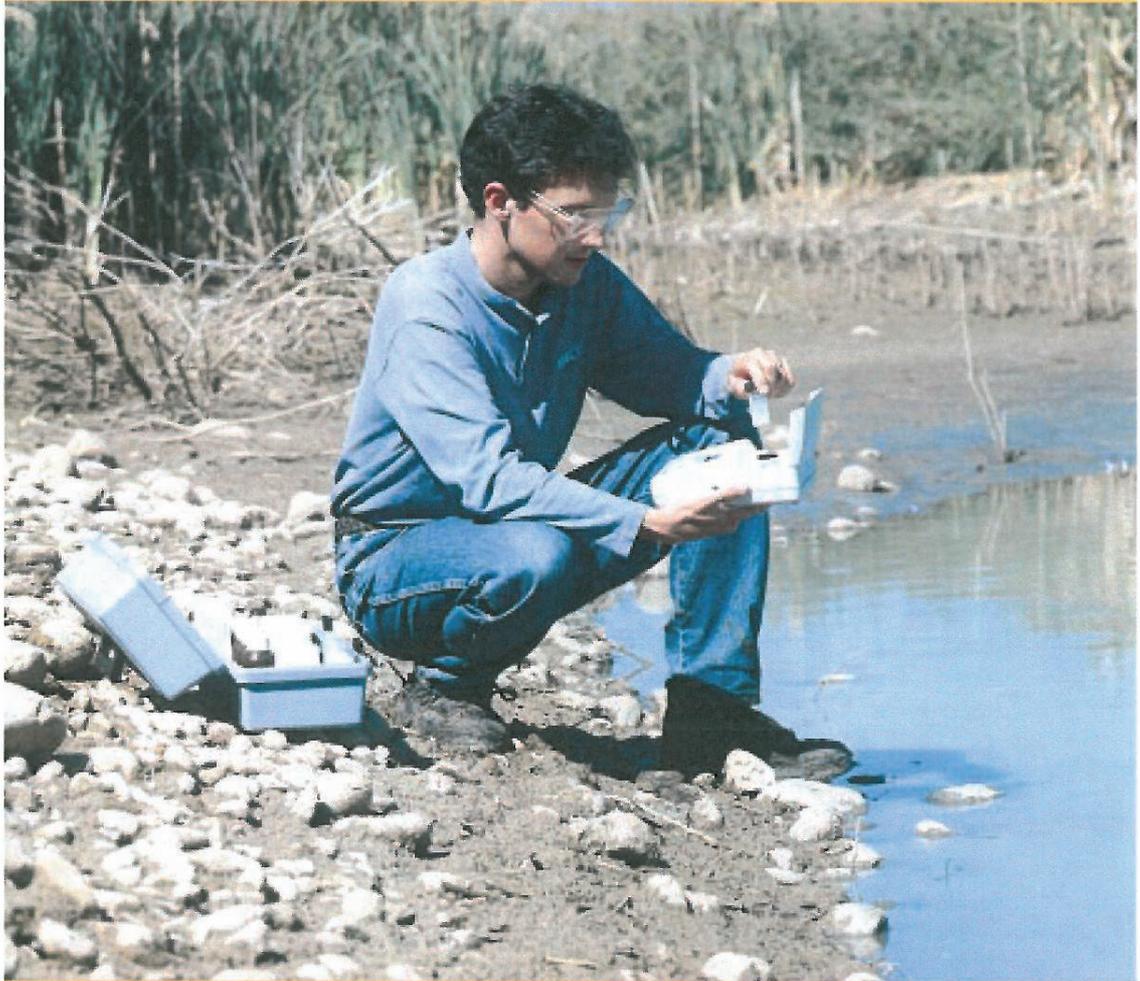
2100P Portable Turbidimeter

The 2100P Portable Turbidimeter offers a level of performance previously possible only with laboratory instruments. The 2100P combines microprocessor-controlled operation and Hach's patented Ratio™ optics to bring greater accuracy, sensitivity, and reliability to field testing.

The two-detector optical system compensates for color in the sample, light fluctuation, and stray light, enabling analysts to achieve laboratory-grade performance on a wide range of samples, even under difficult, on-

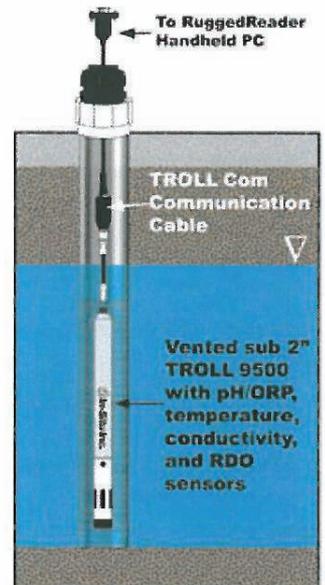
TROLL 9500 Low-Flow Sampling System

You can use the TROLL 9500 System with Flow-Sense Software to conduct low-flow purging and sampling. You will collect representative samples, minimize contaminant volatilization, and reduce hazardous waste disposal. To improve efficiency in the field, the system:
